Naval Surface Warfare Center Carderock Division

NSWCCD-TR-61-1998/30 Nov 1998

An Experimental Evaluation of the Fatigue Behavior of AH36 Weld-Repaired Deck Sockets in a Simulated Marine Atmosphere

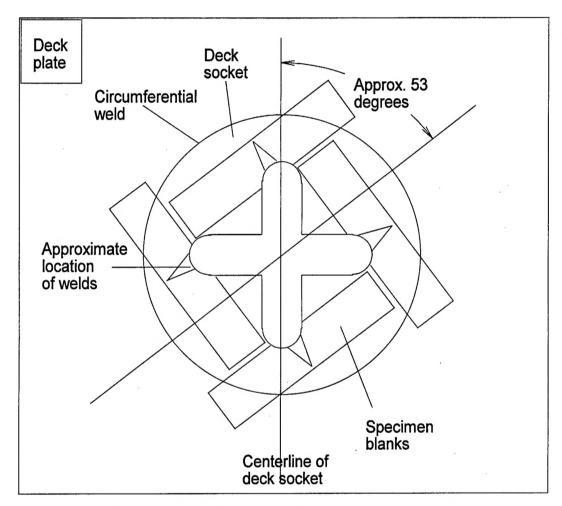
Figure 1 Orientation of test specimens removed from cloverleaf deck sockets.

The specimens were machined from the weld-repaired deck sockets as shown in Fig. 1. The weld face and backing weld face were ground flush with the deck socket thickness. The concave surface of the deck socket lobe was *not* ground and was tested in the as-welded condition (see Fig. 2). The configuration of the specimens simulates as closely as possible the loading orientation of the deck sockets due to actual ship deck stresses. The specimens were tested in three-point bending as shown in Fig. 2. An R-ratio (P_{min}/P_{max}) of 0.1 was selected for two reasons: (1) x-ray diffraction measurements indicate the possibility of residual tensile stresses in the deck socket that will result in tension-tension fatigue when the alternating ship deck stresses are superimposed and (2) R>0 is a more severe case than R<0 for a constant cyclic stress amplitude³. Testing was performed in load control at a frequency of 10 Hz under neutral conditions, and 0.1 Hz under intermittent salt spray conditions.

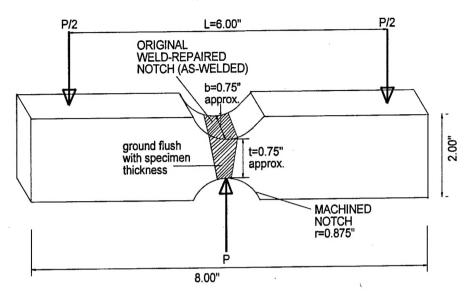
Figure 2 - Schematic of weld-repaired fatigue test specimen.

Eight AH36 deck sockets (S1, S3-S9) were provided to NSWCCD for test specimens. Measured mechanical properties of the base metal are listed in Table I. Weld repairs were performed at each intact lobe of the cloverleaf (some lobes had been sectioned for previous tests). A through-thickness V-groove that extended from the socket lobe towards the circumferential weld (\sim 1.5-in. in length, $30^{\circ}+5^{\circ}/-0^{\circ}$ bevel angle, a 0.0625 ± 0.03125 -in. root opening) was ground into each lobe (see Fig. 1) and subsequently repaired. A ceramic backing was used to control the backing weld contour. The area to be welded was pre-heated to 150° F and welding progressed from the circumferential weld towards the center of the deck socket. Filler metal ER70S-2 or ER70S-3 was employed.

where k_t is the stress concentration factor of the weld-repaired notch (which does not take into account the as-welded surface), L is the distance between the two loading points (loading span), b is the specimen thickness (equal to ~ 0.75 -in., the deck plate thickness) and t is the transverse specimen height (see Fig. 2).

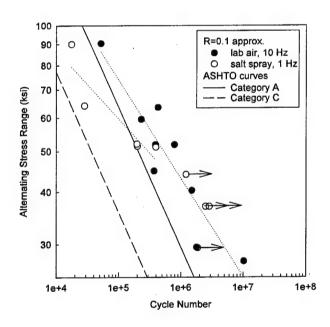
Figure 3 Alternating applied stress versus cycles to failure for weld-repaired AH36 deck sockets tested in three-point bending.

Figs. 3 and 4 show that there is a negligible effect of the salt spray schedule at the longer fatigue lives that were obtained in this study. This may be due to the irregular contour of the weld and its large effect on the fatigue life. Other studies have shown improved fatigue initiation resistance upon increases in the contact angle between the weld and the basemetal at the toe of the weld⁷ or the removal of the weld reinforcement⁸. The role of this surface in fatigue initiation is shown here by the observed fracture initiation at the weld/base metal interface within the fusion zone. This interface acts as an additional stress concentrator and initiation is aided by the difference in strength between the weld metal and the base metal, as mentioned earlier. It was also observed that the specimens that fractured within the weld possessed large lack of fusion or penetration defects that possessed a larger stress concentration factor than the surface contour at the fusion zone. These results indicate that large surface irregularities have a dominant effect on fatigue life. These results can explain why little effect of corrosion is observed at long lives. If fatigue initiation is controlled by the large surface irregularities of the weld surface, the smaller inhomogeneities introduced by surface corrosion will have little effect on fatigue initiation behavior. In addition, direct comparison the behavior observed in this study to the behavior obtained under full immersion may not be feasible. It is likely that different corrosion fatigue initiation and propagation mechanisms are acting.

Figs. 3 and 4 show that at high stresses and short fatigue lives ($\Delta \sigma = 1.2-1.7\sigma_y$), a significant effect of the salt spray schedule was observed. A study discussed previously showed an effect of saltwater immersion on the low cycle fatigue behavior of notched specimens⁴; however, the magnitude of the effect was less than in the high cycle regime.

The data in Fig. 3 is consistent with the specimen size dependencies described above. The small-scale specimens removed from the deck sockets do show higher fatigue strengths and a more positive exponent m compared to the large-scale AASHTO specimens. The deck sockets do not contain welds larger than those tested in the small-scale specimens. However, the effect of defect distribution still remains due to the limited number of specimens that were tested. It is possible that we did not sample a specimen with a defect large enough to result in a lower bound value, while there are enough weld-repaired deck sockets present in a ship to result in a high probability that one does exist. In addition, the state of residual stress and constraint in the small-scale

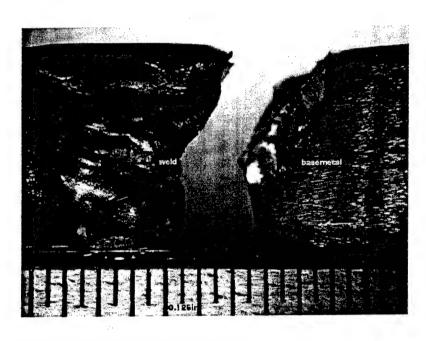
All of the specimens, with the exception of two (S4#2 and S5#1), showed fatigue initiation and propagation in or near the fusion zone (i.e., at the weld/basemetal interface). Fig. 5 shows a macrograph of a typical (fully fractured) specimen viewed parallel to direction "t" in Fig. 2, looking down on the concave surface of the notch. It appears that the irregular surface geometry at the weld/base metal interface in the vicinity of the maximum stress served as a stress concentrator. In addition, since the weld material is harder than the base metal, one can surmise that the plastic deformation becomes localized within the softer base metal, becoming the preferred path for fatigue fracture.

Figure 5 Optical macrograph of typical specimen tested in air showing fracture along weld and base metal interface.

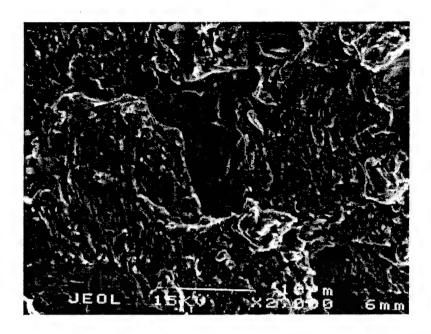
The fracture surfaces of selected specimens are shown in Figs 6 and 7. Specimen S7#1 tested at $\Delta \sigma$ =90 ksi=1.7 σ_y and specimen S6#2(1) tested at $\Delta \sigma$ =30 ksi=0.6 σ_y were compared. The fracture mode showed a typical fatigue fracture morphology. The specimen tested at high stress (Fig. 6) showed more sharply defined and largely spaced

Figure 6 Scanning electron micrograph of specimen S7#1 near fatigue crack tip $(\Delta \sigma = 90.4 \text{ ksi} = 1.7\sigma_y, N_f = 51,863 \text{ cycles.})$

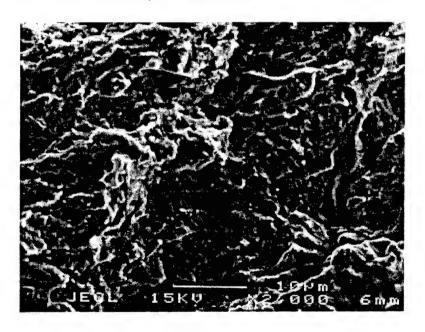
Figure 7 Scanning electron micrograph of specimen S6#2(1) near fatigue crack tip ($\Delta \sigma$ =30.4 ksi=0.6 σ y, N₆=10,302,827 cycles.)

fatigue striations (or striation bundles) compared to the specimen tested at a low stress (Fig. 7), as expected.
